Sao Paulo Metro System – Sacoma Station: A Case History

ABSTRACT: Megacities demand more and more mass transportation services in order to keep the balance between both growing in size and efficiency. The need of transport infrastructure within increasingly restrained spaces and difficult geotechnical conditions pose a challenge to engineers. This paper presents a typical case of a metro station built under difficult geological conditions in a tight space of a megacity: the design and construction of Sacoma Station in Sao Paulo, Brazil. Local conditions, design requirements, engineering decisions and field performance are discussed next.

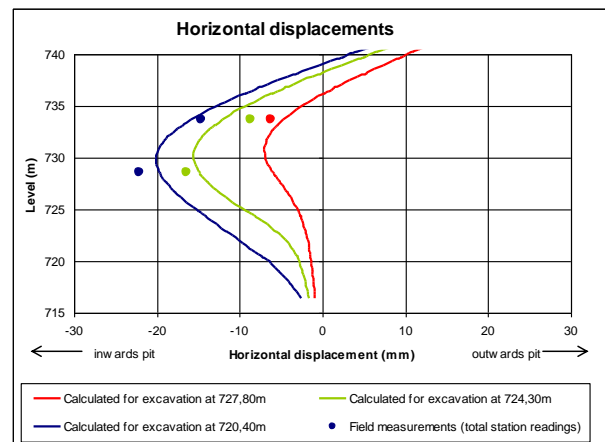
Monitoring proved essential to assess support performance. Field performance assessment and comparison between measured and predicted displacements pictured a good overall field performance. Figure 13 shows predicted and measured horizontal displacements of the main supporting wall. Measures of horizontal displacements were taken from convergence points, while predicted ones result from numerical analysis. Note that all predicted values shown refer to type A predictions according to Lambe (1973), performed before construction.

Figure 13. Measured and predicted horizontal displacements of Main Pit support wall.

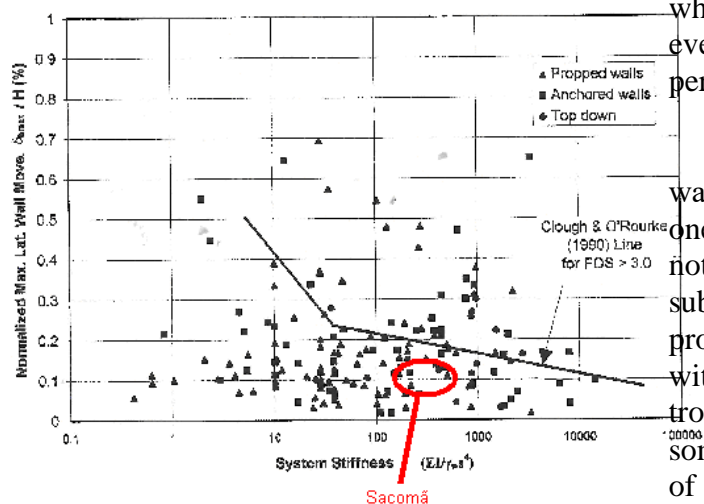
Figure 14 shows where the measured horizontal displacements lay among available data gathered by Long (2001). Long reviewed past work and established an updated database for ground movements associated with deep excavations involving 269 case records with strutted, tie-back anchored, or top-down supported walls, and 27 cases of cantilever walls. It can be seen that the displacements measured at Sacoma Station agrees with other similar observations made around the world. Figure 14 also shows the line proposed by Clough & O'Rourke (1990), which relates system stiffness and ground movement for walls with bottom heave safety factor greater than 3.0.

Figure 14. Measured horizontal displacements at Sacoma Station and Long (2001) database.

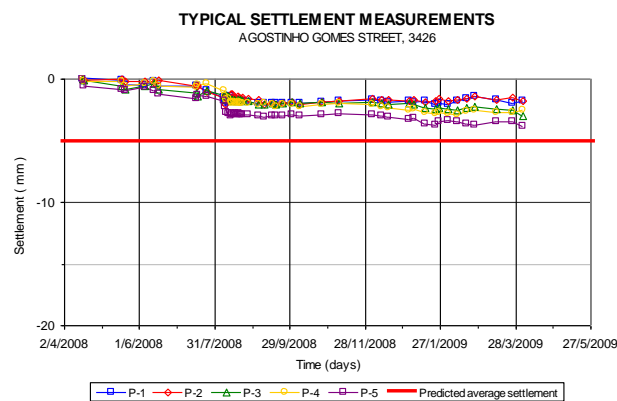
Figure 15 shows the typical results of settlement measured at settlement points installed at neighbouring buildings columns. It can be seen that settlements are low, in the same range of the predicted ones.

Figure 15. Typical settlement measurement results.

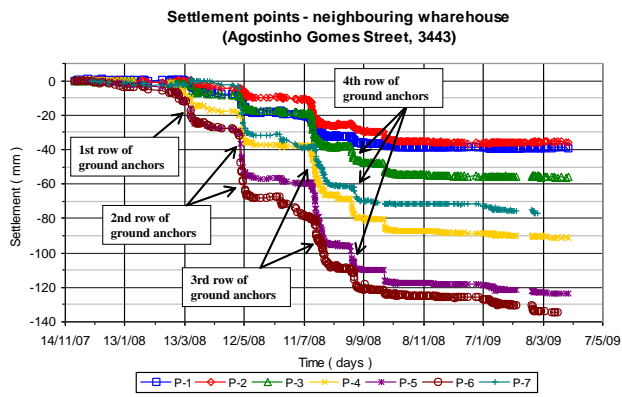
One typical case of conflicting objectives was seen during ground anchor's drilling. On one hand the drainage preventing valve was not available by the ground anchors subcontractor, and on the other hand very high production rates were achieved when drilling with water injection at pressures far too high through very soft clays. As a consequence, some parts of the wall experienced heavy loss of soil and water during drilling of ground anchors, especially around North Access Pit. Major damage and interdiction was reported on a neighbouring warehouse, although major damage was already predicted for this structure during damage analysis. This was the only interdiction made during excavation works. Minor damages were reported on other surrounding buildings, and in most cases they were also related to ground anchors' drilling. Figure 16 shows measured settlements of the interdicted warehouse, clearly showing the deleterious effect of drilling with such high pressures throughout very soft clays. Compare it with settlements shown in Figure 15.

Figure 16. Effect of drilling with high pressure injection water throughout soft clay on a neighbour warehouse.

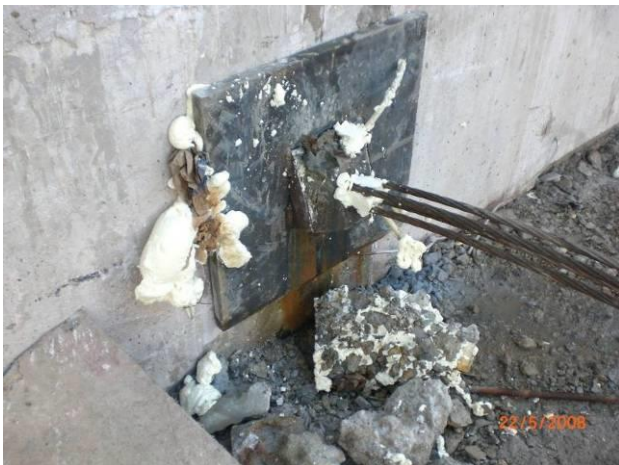
Figure 17. Ground anchor head treated with polyurethane expansive foam.

An attempt to control water losses through anchor's heads was made by means of sealing it with polyurethane expansive foam. The solution gave fair results, not eliminating but reducing water losses to a great extent. Figure 17 shows a ground anchor head just after application of the expansive foam.

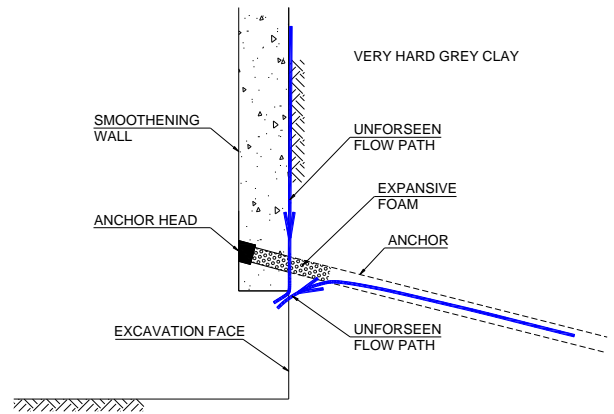
Total elimination of water loss was not possible because water was able to found different flow paths not previously predicted by design team. Some water loss was reported coming from behind the retaining wall, as shown schematically in Figure 18. Figure 19 show a major water loss (later treated with expansive foam), probably due a flow path as the ones shown in Figure 18, and Figure 20 show some small seepage that continued through ground anchor's heads even after treatment with the expansive foam.

Figure 18. Unpredicted flow paths behind the retaining wall.

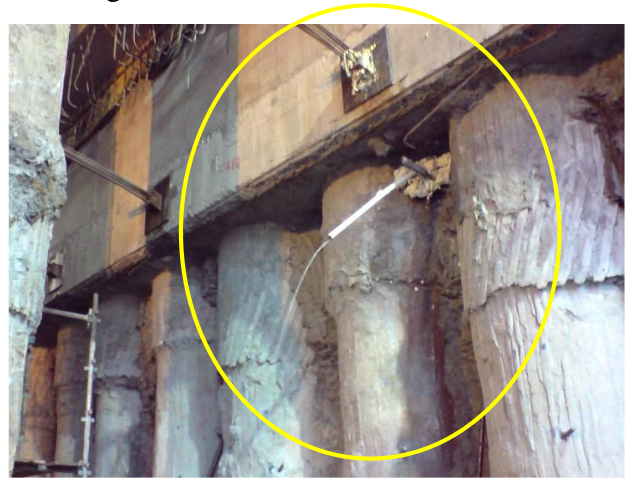
Figure 19. Major water loss due to an unpredicted flow path.

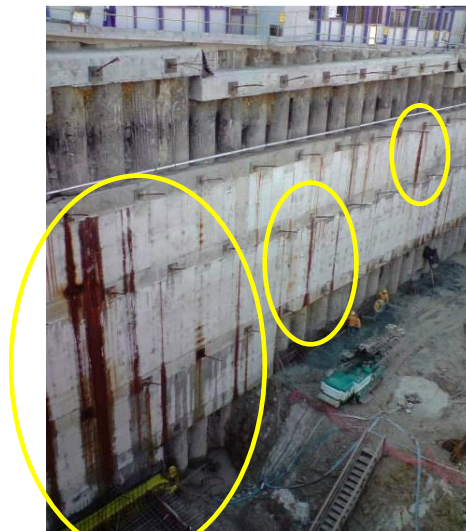
Figure 20. Seepage through ground anchor's heads.

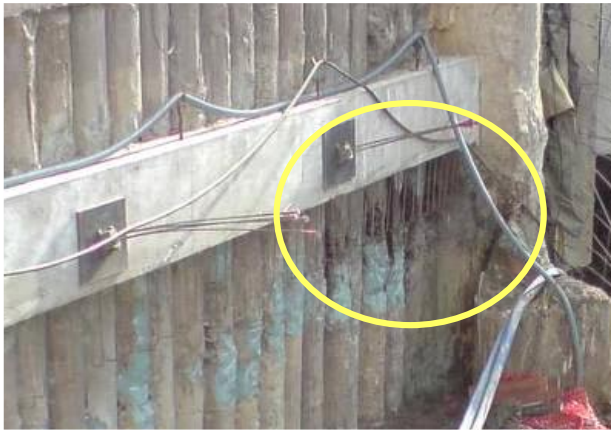
Ground water lowering was also worsened by gross defects on the secant bored piles: concrete faults and verticality problems contributed to poor sealing performance of the support system at the ancillary pits. Figure 21

shows a void in the concrete of the bored secant piles.

Figure 21. Example of concrete fault in the bored secant piles.

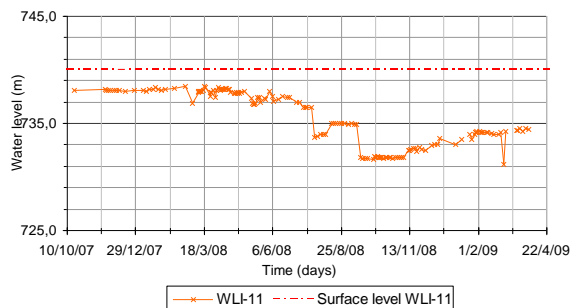
Ground water lowering was confirmed by water level indicators readings, as shown in Figure 22. Besides ground water lowering that did occur, no major damages were recorded on the station's vicinity, in part because most of the buildings have pile foundations, in part because the soft soil was found to be slightly preconsolidated.

Figure 22. Water level lowering registered.
